Manhole Inspection Summary

Manhole # S33A__039MH

Location Address: **ALLEY 610 CATHEDRAL ST**

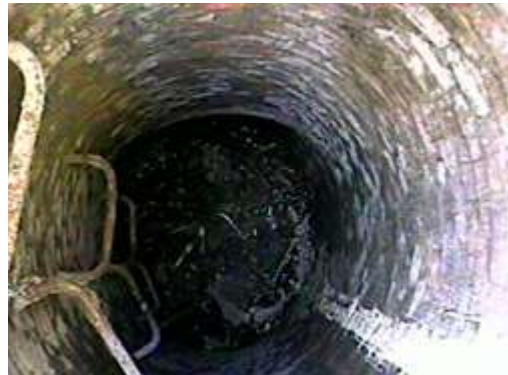
Top View

DEBRIS IN CHANNEL

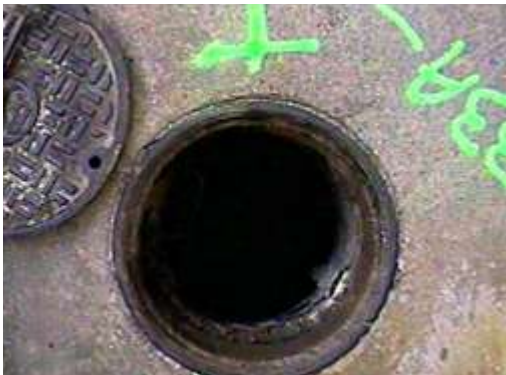
Top View

Frame Offset: **3** (in.) Condition: ☒ Sound ☐ Cracked ☐ Leaks

FRAME OFFSET

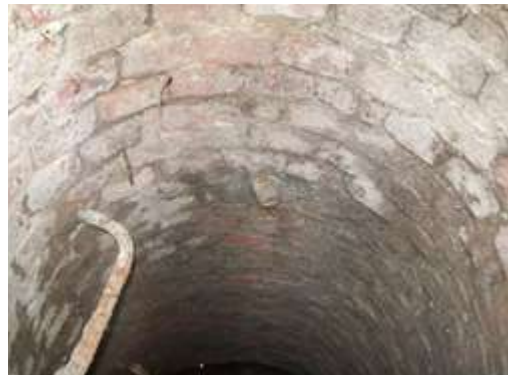
Defect 4

Steps Count: **6** Missing: **0** ☒ **Corroded**

CORRODED STEPS

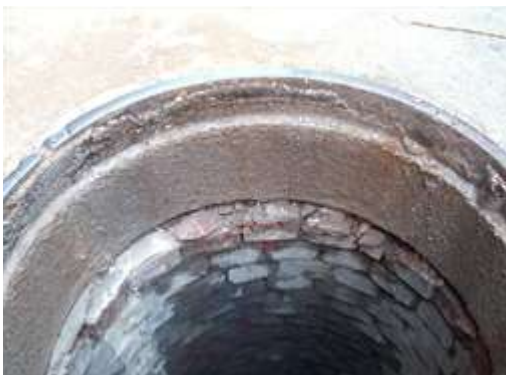
Defect 1

Condition: ☐ Sound ☐ Cracked ☐ Root Intrusion ☐ Loose Brick ☒ **Deteriorated**

DETERIORATED CHIMNEY

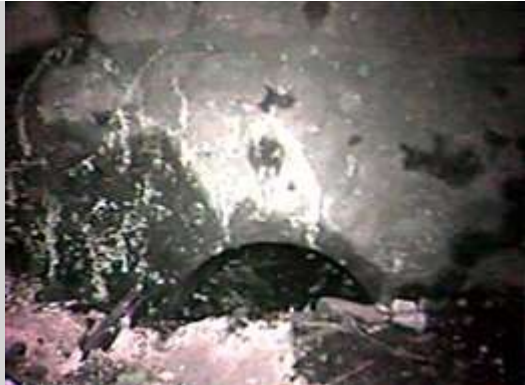
12 O'Clock Outflow

Deposits: ☐ None ☐ Mud ☐ Sludge ☒ **Debris** ☐ Grease

Silt Depth: **5** (in.) Deposits Extent: **Heavy**
